CULTURAL RESOURCE SURVEY
MAIN BUILDING FORM

CRS # K-6778

1. ADDRESS/LOCATION: Cain's Furniture; West Side of SR 1, South Murderkill Hundred, Kent County

1. HISTORIC NAME/FUNCTION: Cain's Furniture Property/Gas Station/Store

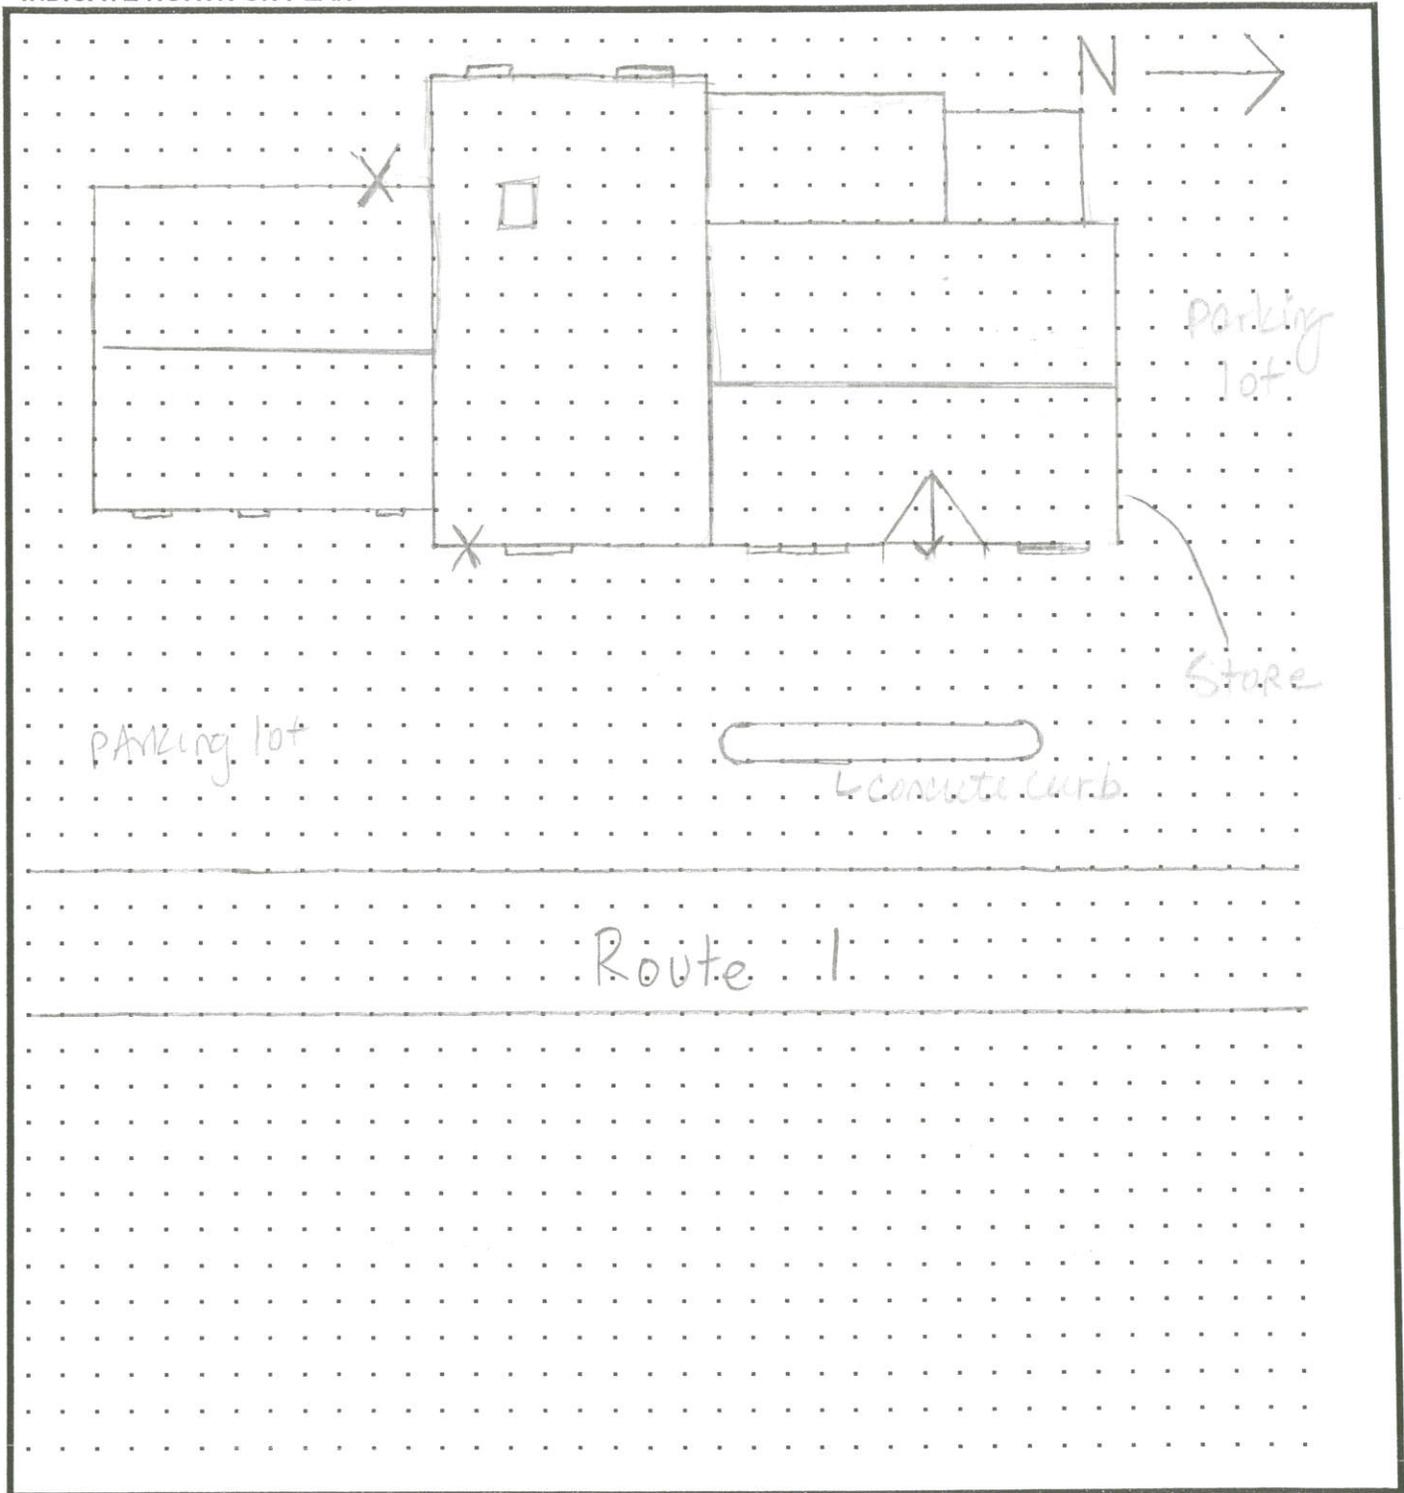
4. SITE PLAN:

5. SETTING INTEGRITY: There is a parking lot surrounding the buildings and a concrete curb island; probably from the time when there was a gas station there.

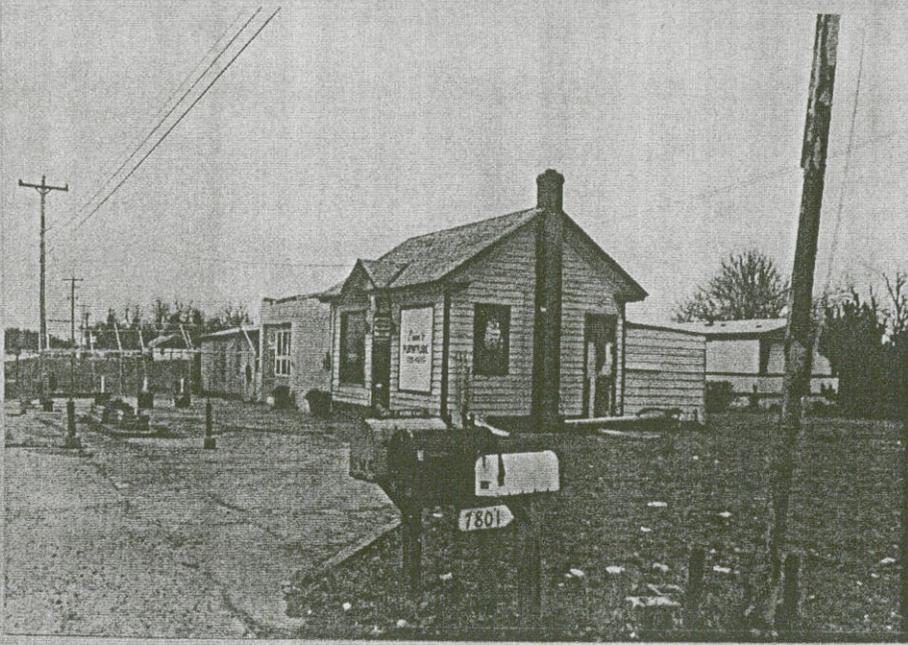
CRS # K-6778 Date 3/98 Contact # C-4266 Surveyor S. Davis

Description Cain's Furniture, from NE
